ASBESTOS MANAGEMENT SURVEY REPORT

Report Number: H4346
On behalf of Hambledon Village Hall & Youth Hut
West Street, Hambledon, Hampshire PO7 4RW

**Hambledon Village Hall & Youth Hut
West Street
Hambledon
Hampshire
PO7 4RW**

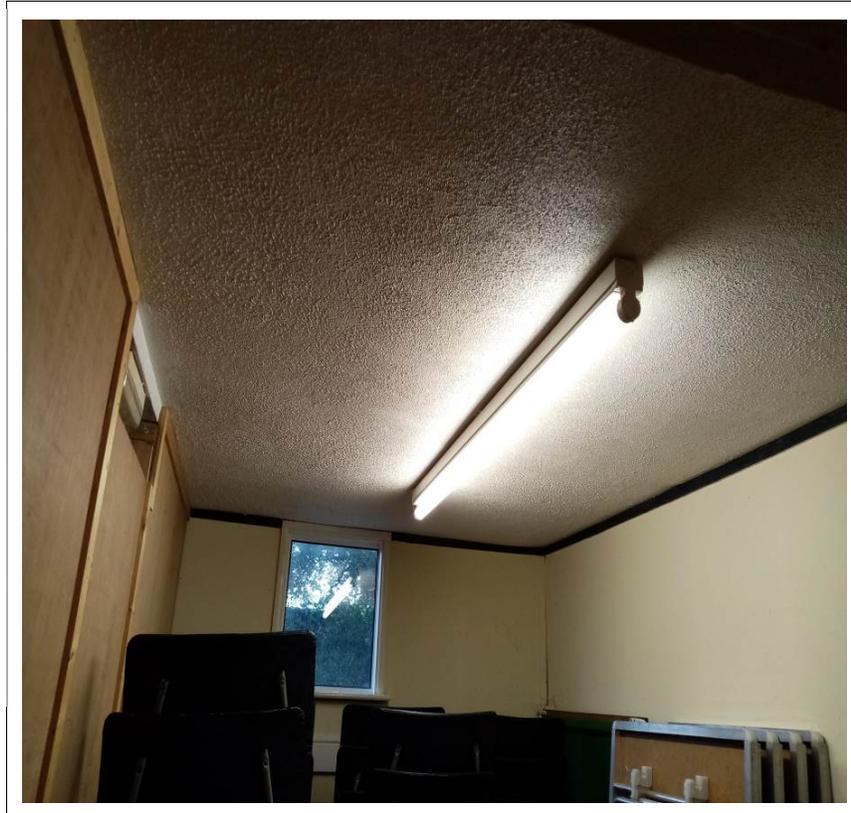
PHOTOPLATE 001

Location	G.01 – Store
Item No.	01
Sample Reference (Bulk ID)	AA21310 B01
Product Details	Textured coating to ceiling
Analysis Result	NAD
Risk Level	-
Recommendation	-

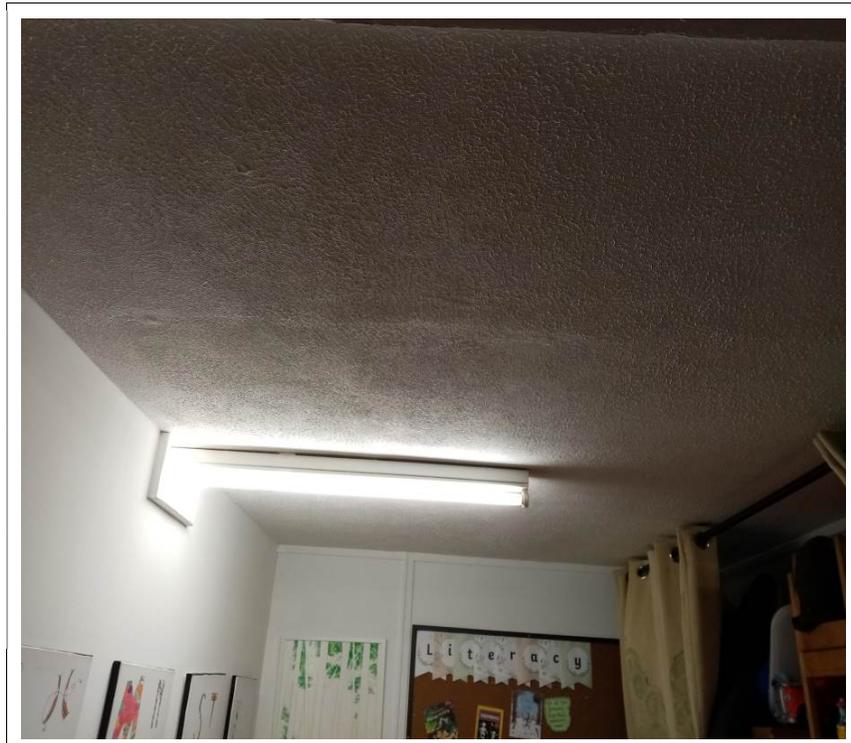
PHOTOPLATE 002

Location	G.02 – Store
Item No.	-
Sample Reference (Bulk ID)	Ref.01
Product Details	Textured coating to ceiling
Analysis Result	NAD
Risk Level	-
Recommendation	-

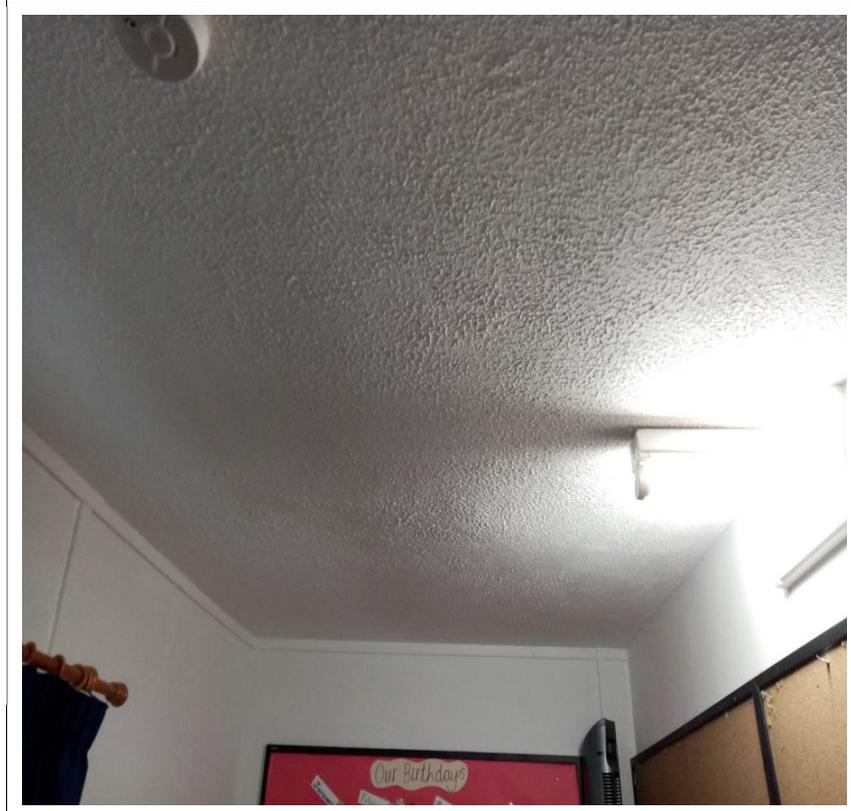
PHOTOPLATE 003

Location G.03 – Store
Item No. -
Sample Reference (Bulk ID) Ref.01
Product Details Textured coating to ceiling
Analysis Result NAD
Risk Level -
Recommendation -

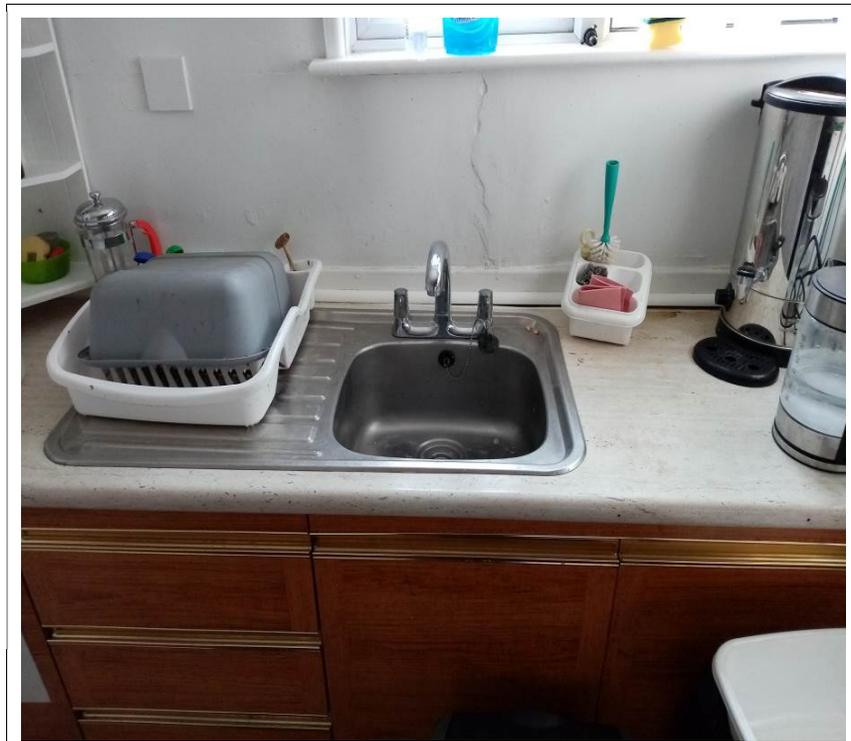
PHOTOPLATE 004

Location G.07 – Kitchen & Cupboard
Item No. 02
Sample Reference (Bulk ID) AA21310 B02
Product Details Bitumen sink pad
Analysis Result NAD
Risk Level -
Recommendation -

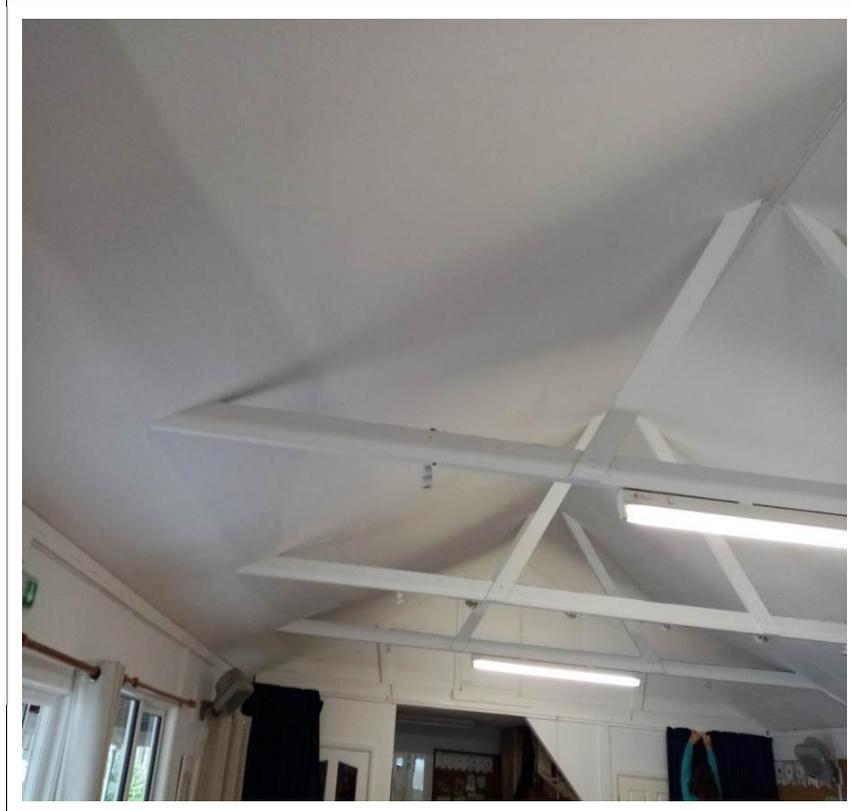
PHOTOPLATE 005

Location	G.08 – Hall
Item No.	03
Sample Reference (Bulk ID)	AA21310 B03
Product Details	Textured coating to ceiling
Analysis Result	NAD
Risk Level	-
Recommendation	-

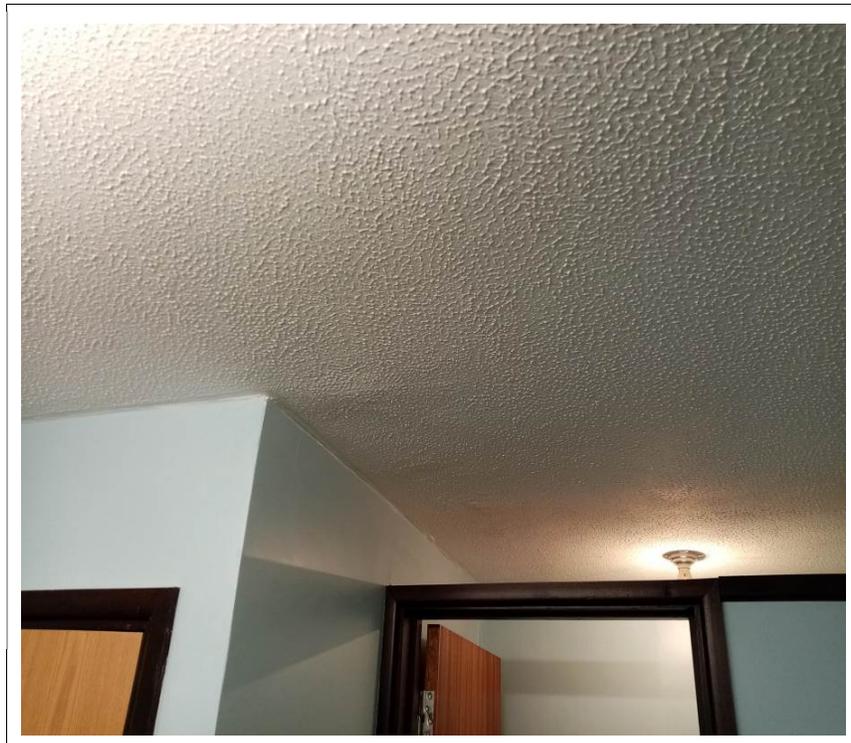
PHOTOPLATE 006

Location	G.09 – Male W.C & Lobby
Item No.	04
Sample Reference (Bulk ID)	AA21310 B04
Product Details	Textured coating to ceiling
Analysis Result	NAD
Risk Level	-
Recommendation	-

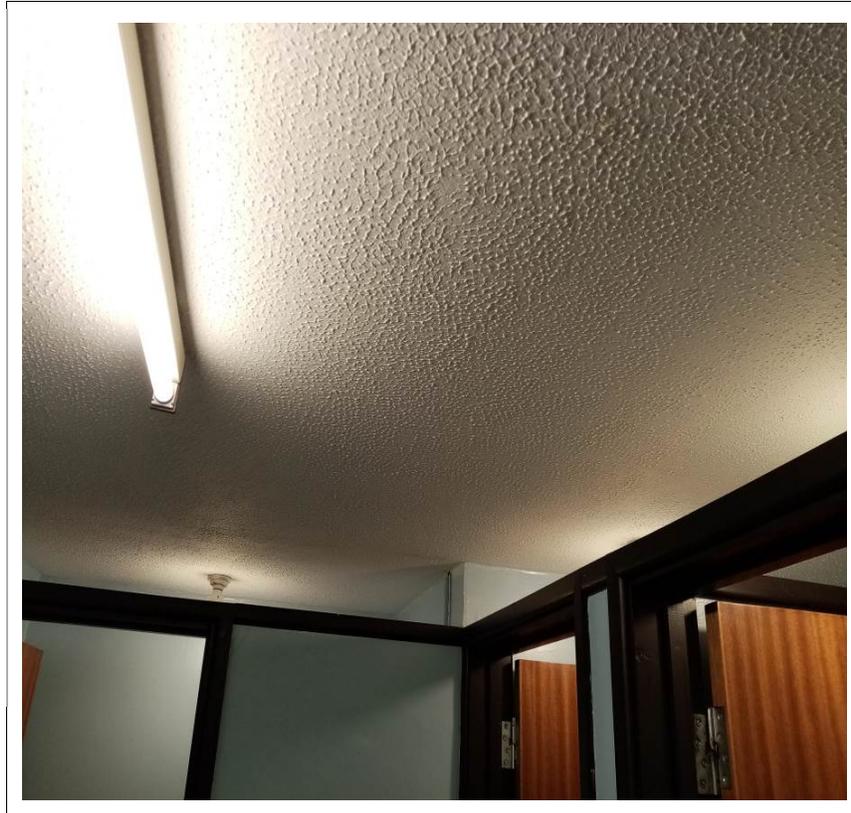
PHOTOPLATE 007

Location G.11 – Female W.C & Lobby
Item No. -
Sample Reference (Bulk ID) Ref.04
Product Details Textured coating to ceiling
Analysis Result NAD
Risk Level -
Recommendation -

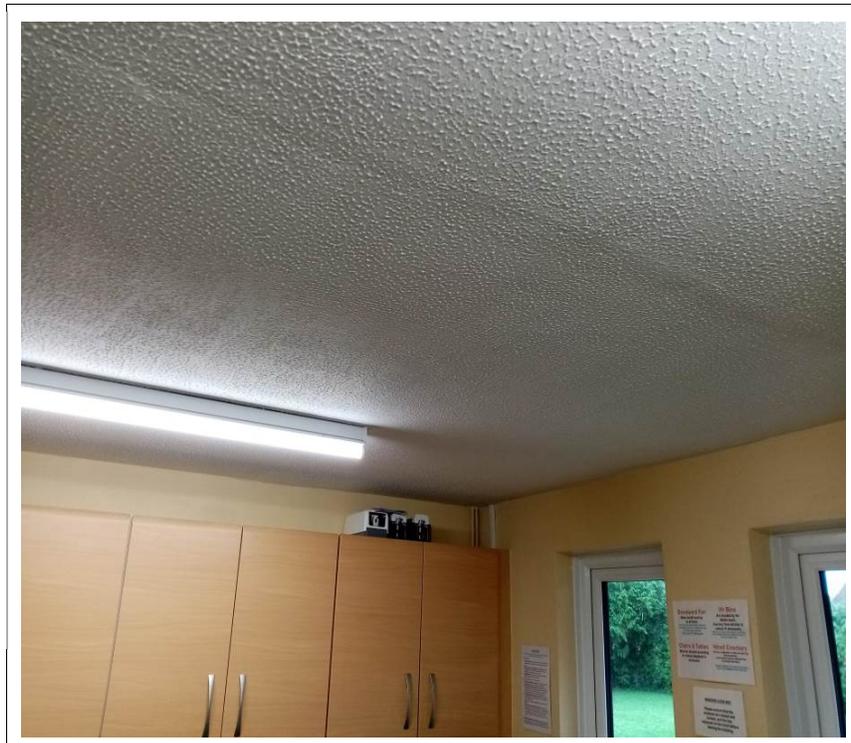
PHOTOPLATE 008

Location G.12 – Kitchen
Item No. -
Sample Reference (Bulk ID) Ref.04
Product Details Textured coating to ceiling
Analysis Result NAD
Risk Level -
Recommendation -

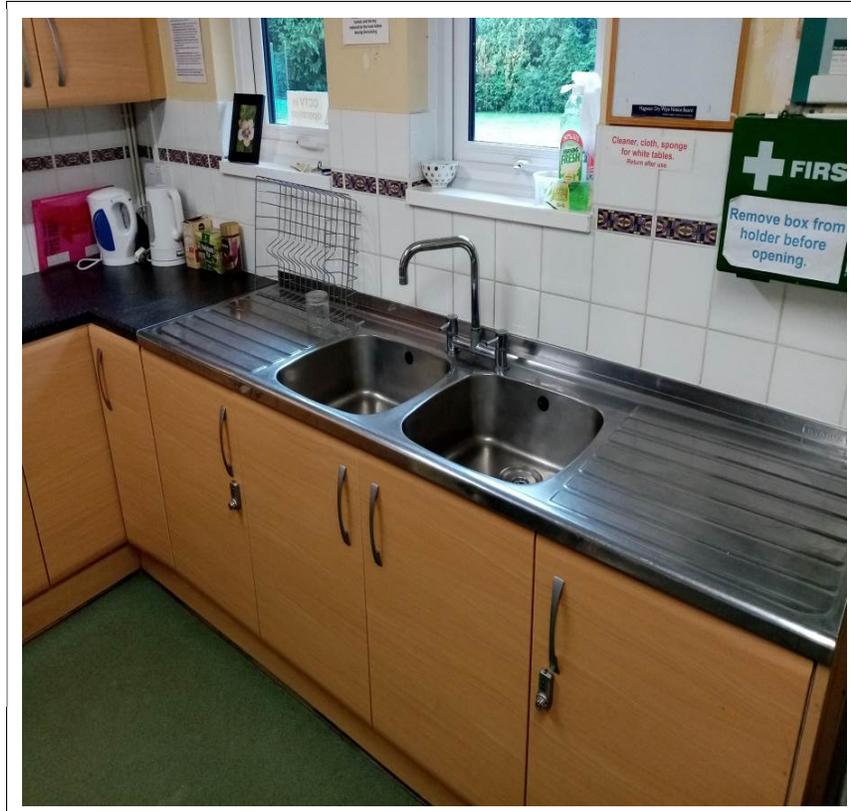
PHOTOPLATE 009

Location	G.12 – Kitchen
Item No.	05
Sample Reference (Bulk ID)	AA21310 B05
Product Details	Bitumen sink pad
Analysis Result	NAD
Risk Level	-
Recommendation	-

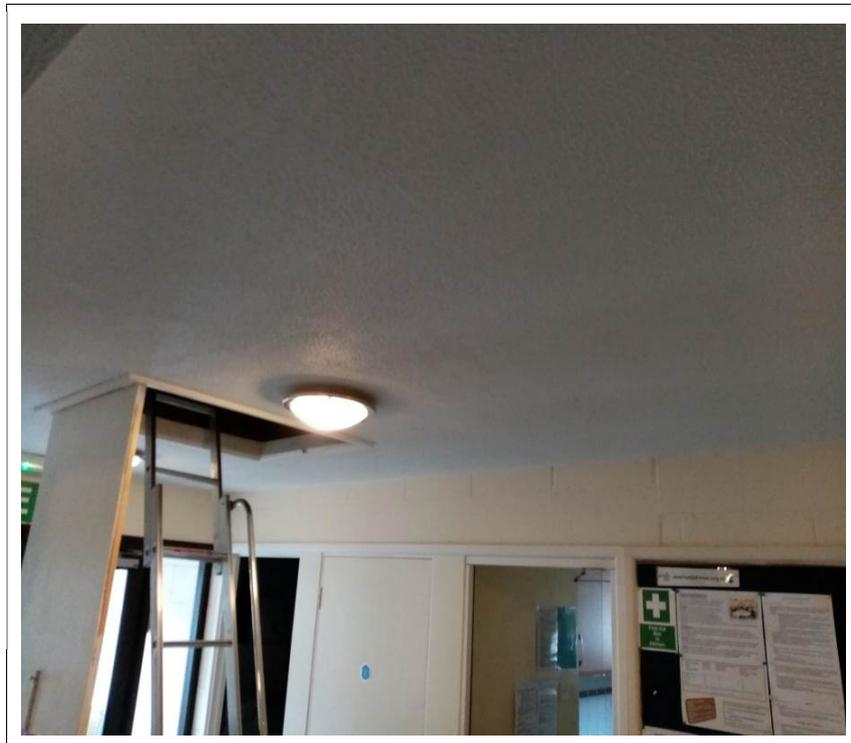
PHOTOPLATE 010

Location	G.13 – Lobby
Item No.	-
Sample Reference (Bulk ID)	Ref.04
Product Details	Textured coating to ceiling
Analysis Result	NAD
Risk Level	-
Recommendation	-

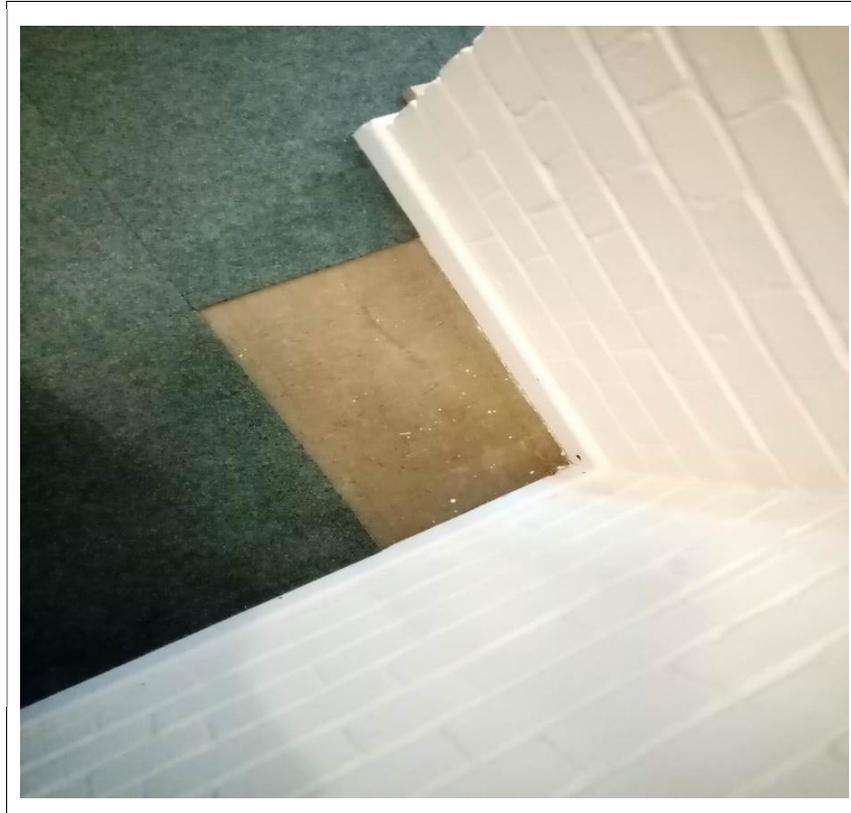
PHOTOPLATE 011

Location	G.13 – Lobby
Item No.	06
Sample Reference (Bulk ID)	AA21310 B06
Product Details	Vinyl floor tiles & bitumen adhesive
Analysis Result	NAD
Risk Level	-
Recommendation	-

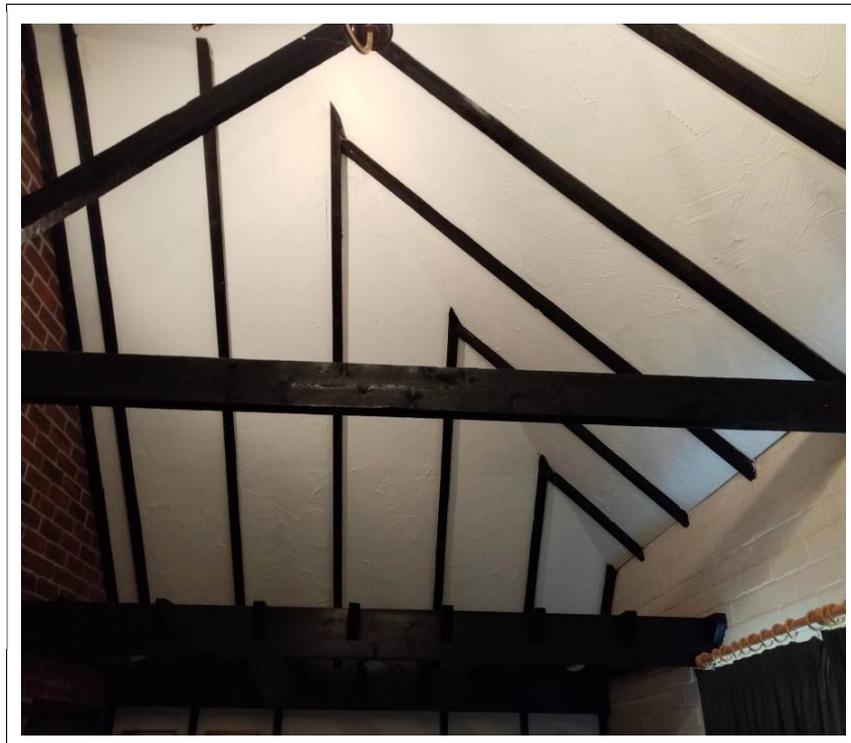
PHOTOPLATE 012

Location	G.14 – Bar
Item No.	07
Sample Reference (Bulk ID)	AA21310 B07
Product Details	Textured coating to ceiling
Analysis Result	NAD
Risk Level	-
Recommendation	-

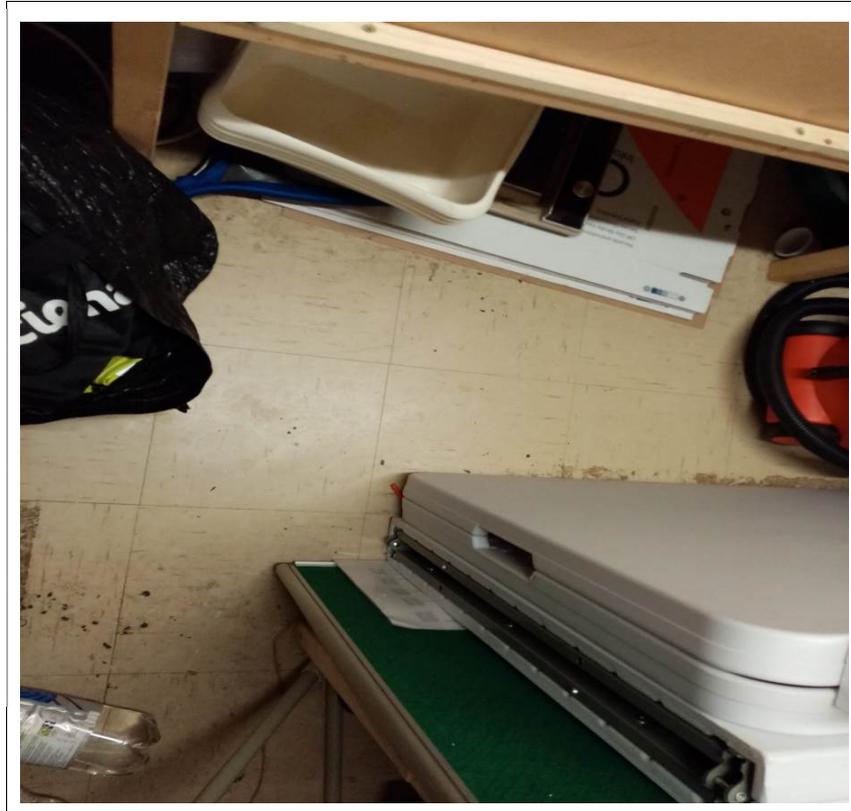
PHOTOPLATE 013

Location	G.15 – Store
Item No.	08
Sample Reference (Bulk ID)	AA21310 B08
Product Details	Vinyl floor tiles & bitumen adhesive
Analysis Result	NAD
Risk Level	-
Recommendation	-

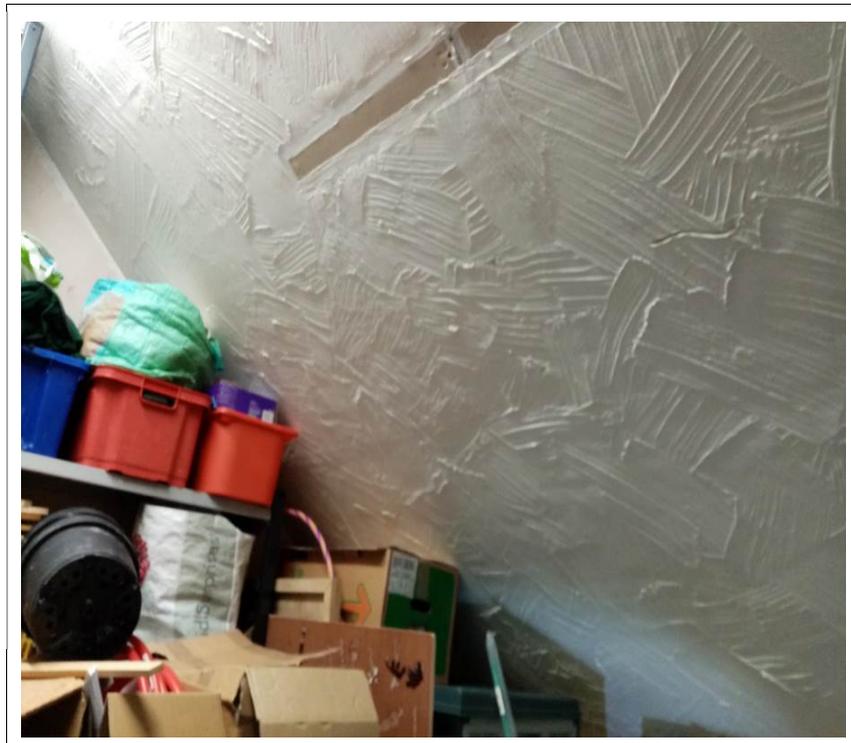
PHOTOPLATE 014

Location	L.03 – Loft 3
Item No.	-
Sample Reference (Bulk ID)	Ref.07
Product Details	Textured coating to ceiling
Analysis Result	NAD
Risk Level	-
Recommendation	-

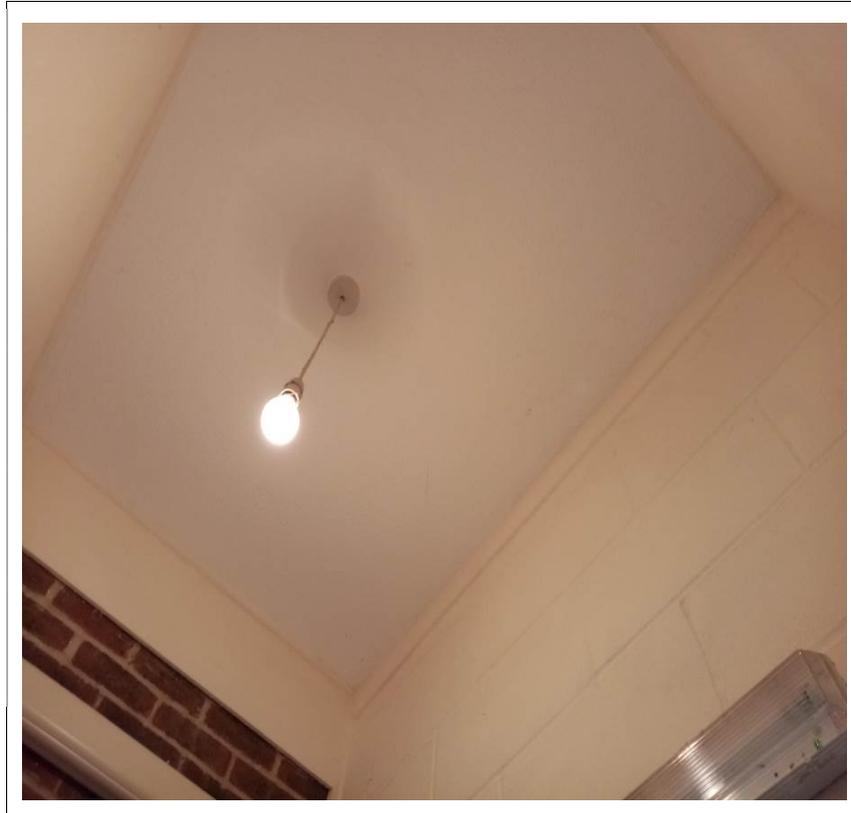
PHOTOPLATE 015

Location
G.17 – Lobby
Item No.
09
Sample Reference (Bulk ID)
AA21310 B09
Product Details
Textured coating to ceiling
Analysis Result
NAD
Risk Level
-
Recommendation
-

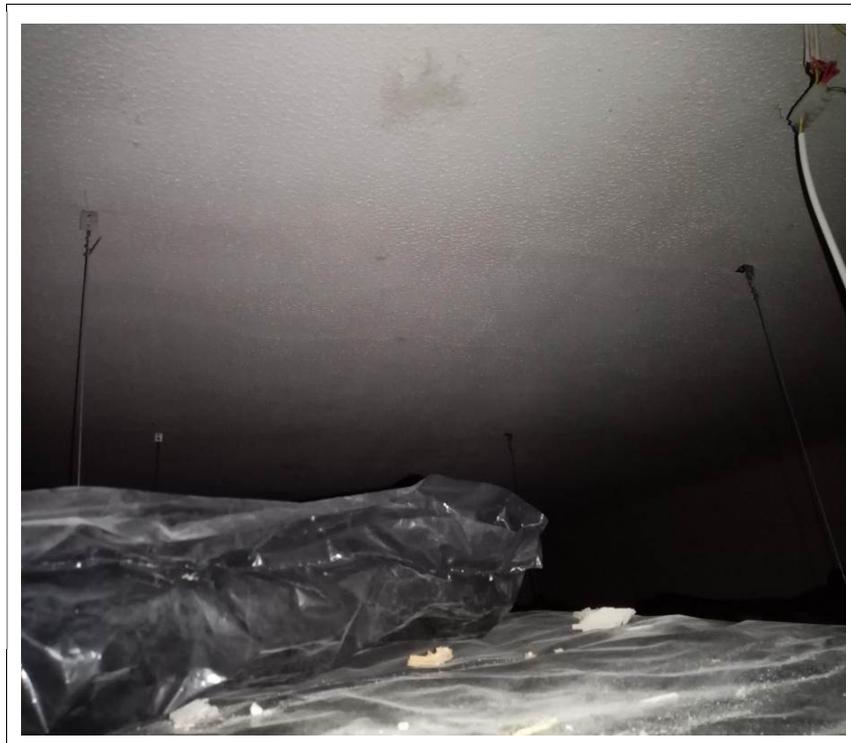
PHOTOPLATE 016

Location
G.18 – Meeting Room
Item No.
-
Sample Reference (Bulk ID)
Ref.09
Product Details
Textured coating to ceiling
Analysis Result
NAD
Risk Level
-
Recommendation
-

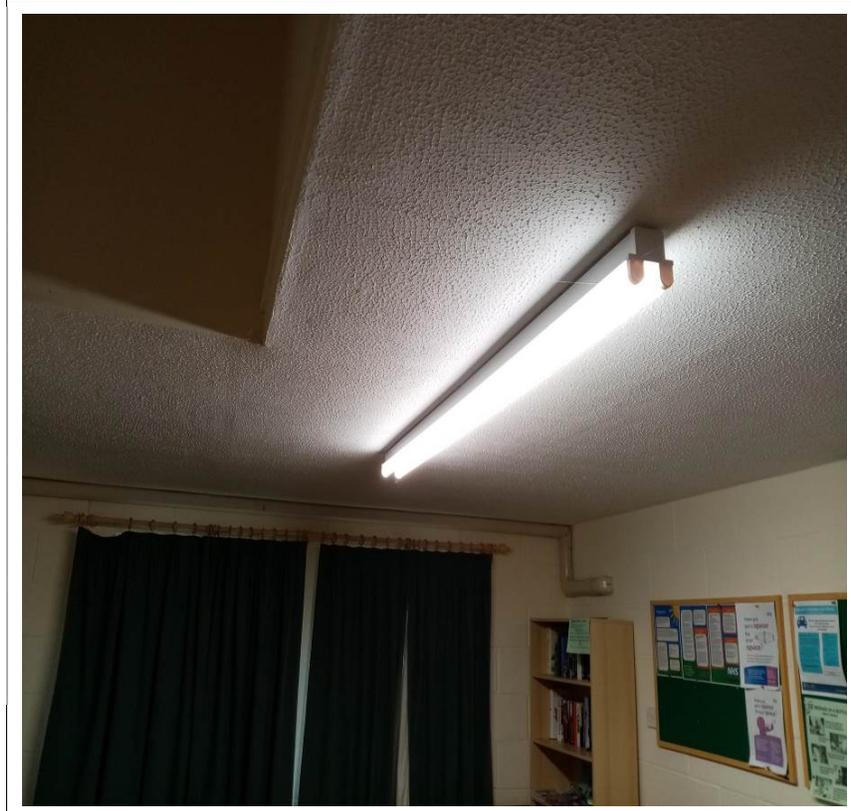
PHOTOPLATE 017

Location	G.19 – Lounge
Item No.	-
Sample Reference (Bulk ID)	Ref.09
Product Details	Textured coating to ceiling
Analysis Result	NAD
Risk Level	-
Recommendation	-

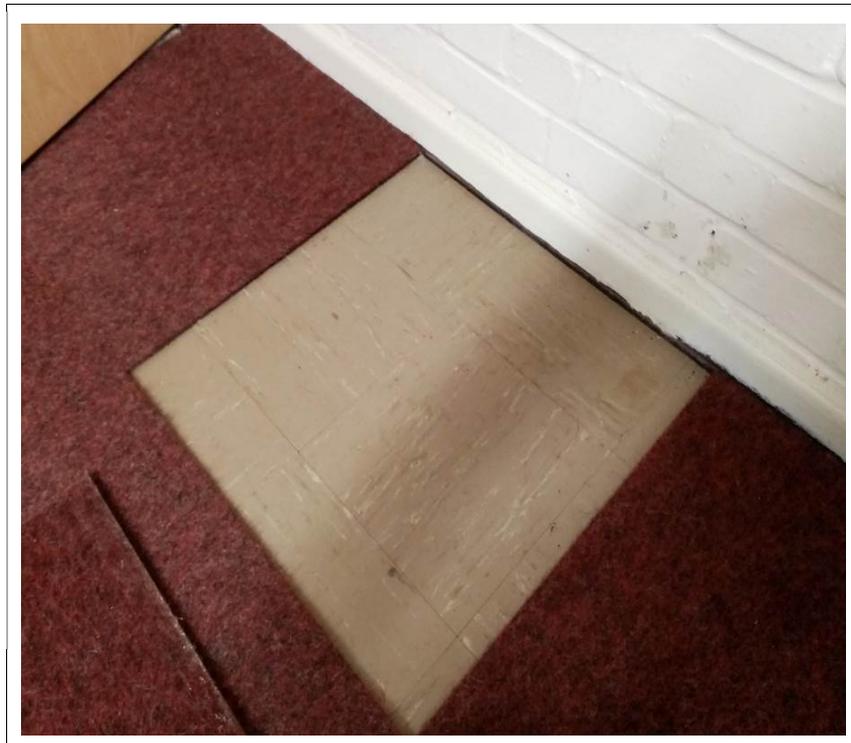
PHOTOPLATE 018

Location	G.19 – Lounge
Item No.	-
Sample Reference (Bulk ID)	Ref.08
Product Details	Vinyl floor tiles & bitumen adhesive
Analysis Result	NAD
Risk Level	-
Recommendation	-

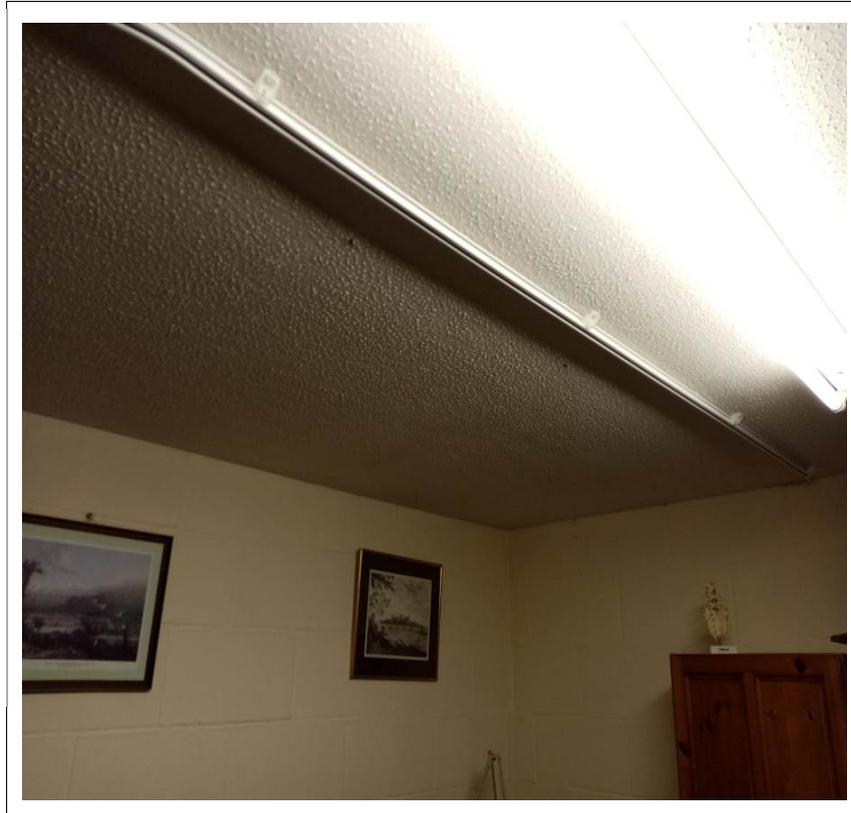
PHOTOPLATE 019

Location G.20 – Office
Item No. -
Sample Reference (Bulk ID) Ref.09
Product Details Textured coating to ceiling
Analysis Result NAD
Risk Level -
Recommendation -

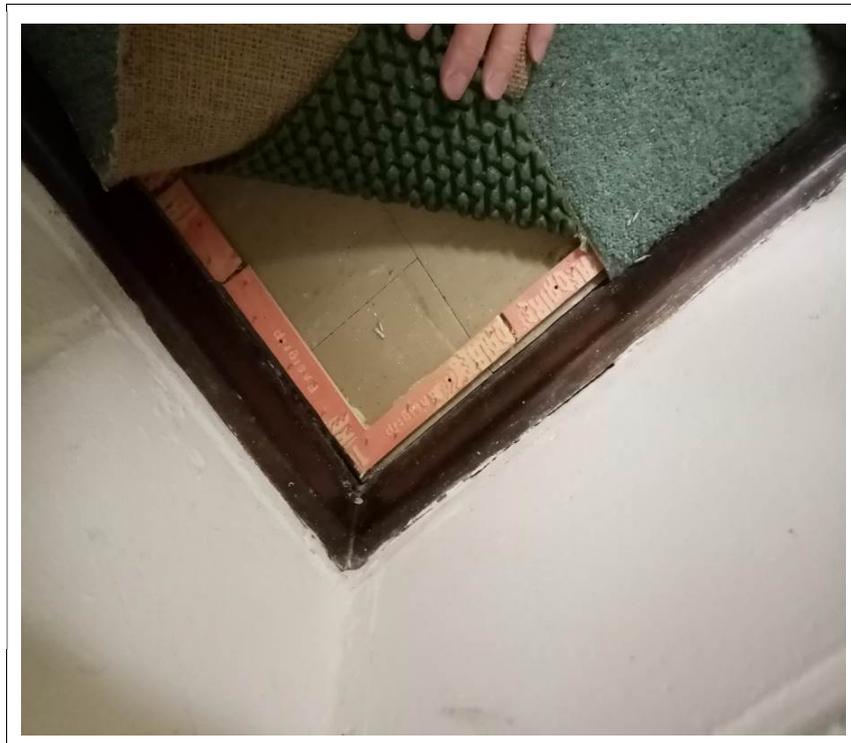
PHOTOPLATE 020

Location G.20 – Office
Item No. -
Sample Reference (Bulk ID) Ref.08
Product Details Vinyl floor tiles & bitumen adhesive
Analysis Result NAD
Risk Level -
Recommendation -

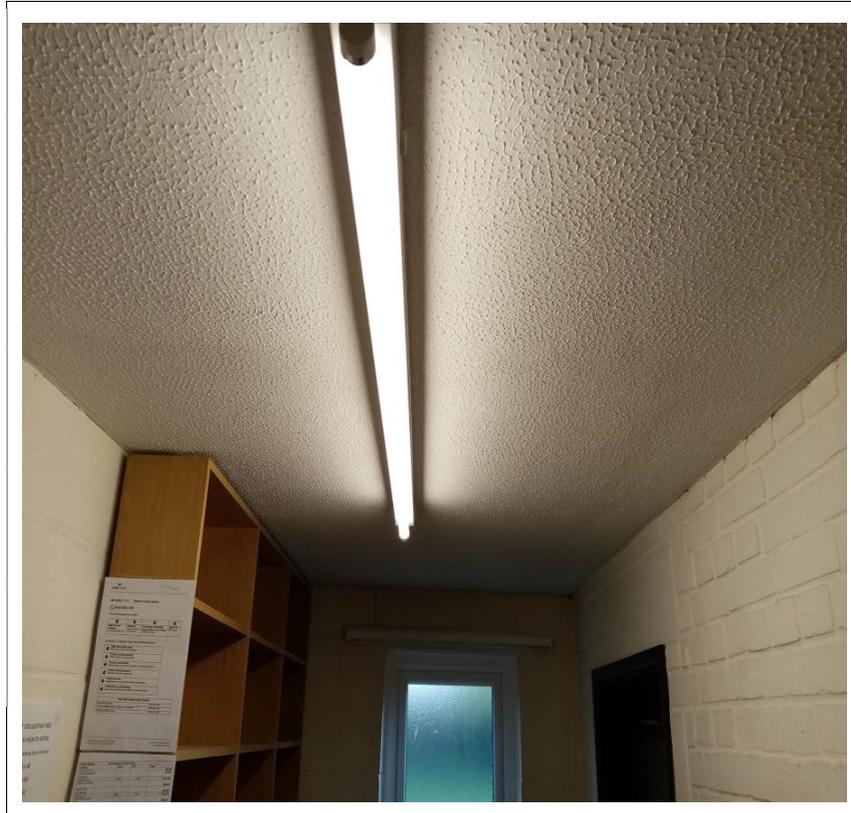
PHOTOPLATE 021

Location
G.21 – Reception & Dispensary
Item No.
-
Sample Reference (Bulk ID)
Ref.09
Product Details
Textured coating to ceiling
Analysis Result
NAD
Risk Level
-
Recommendation
-

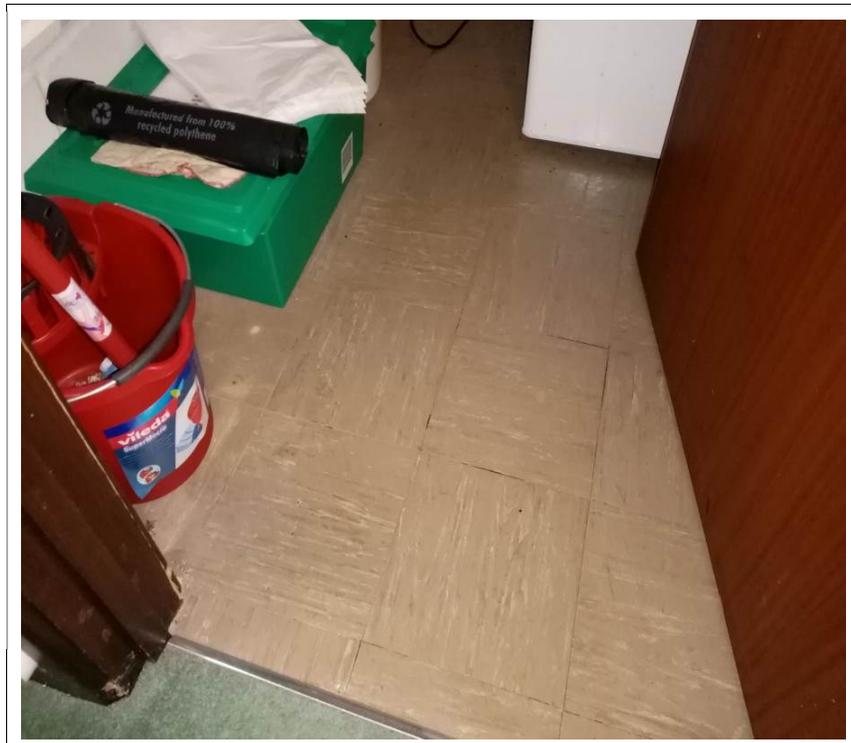
PHOTOPLATE 022

Location
G.21 – Reception & Dispensary
Item No.
-
Sample Reference (Bulk ID)
Ref.08
Product Details
Vinyl floor tiles & bitumen adhesive
Analysis Result
NAD
Risk Level
-
Recommendation
-

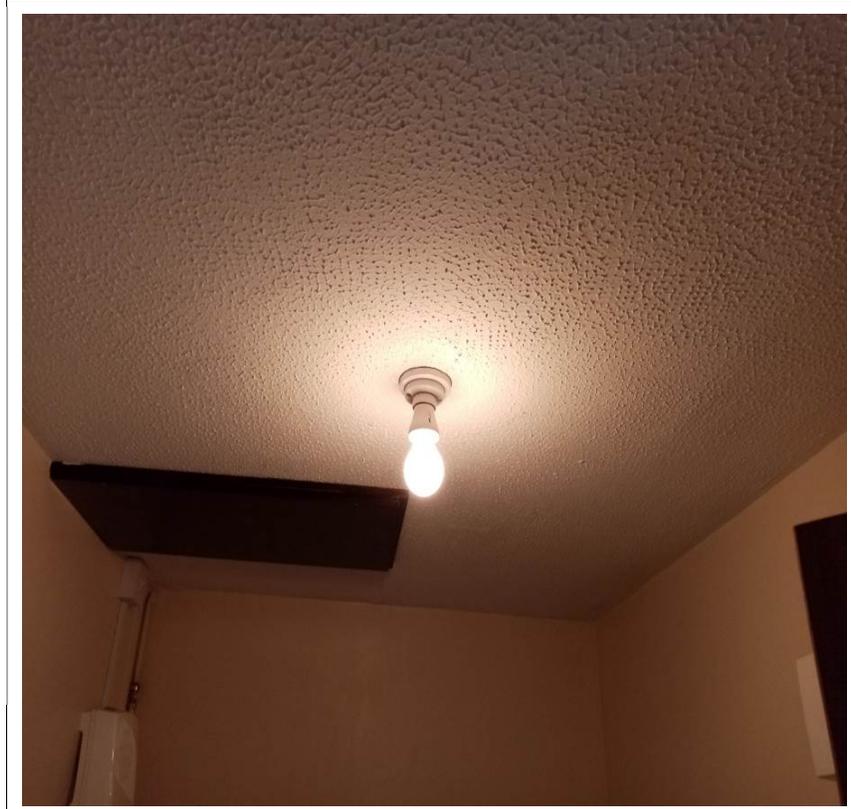
PHOTOPLATE 023

Location G.22 – Disabled W.C
Item No. -
Sample Reference (Bulk ID) Ref.09
Product Details Textured coating to ceiling
Analysis Result NAD
Risk Level -
Recommendation -

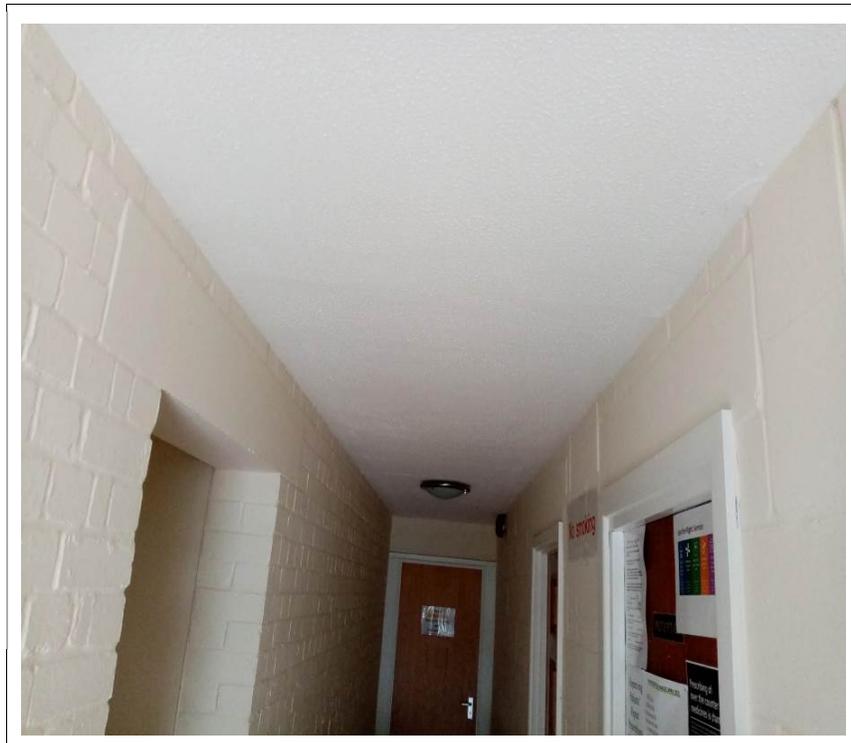
PHOTOPLATE 024

Location G.23 – Corridor
Item No. -
Sample Reference (Bulk ID) Ref.09
Product Details Textured coating to ceiling
Analysis Result NAD
Risk Level -
Recommendation -

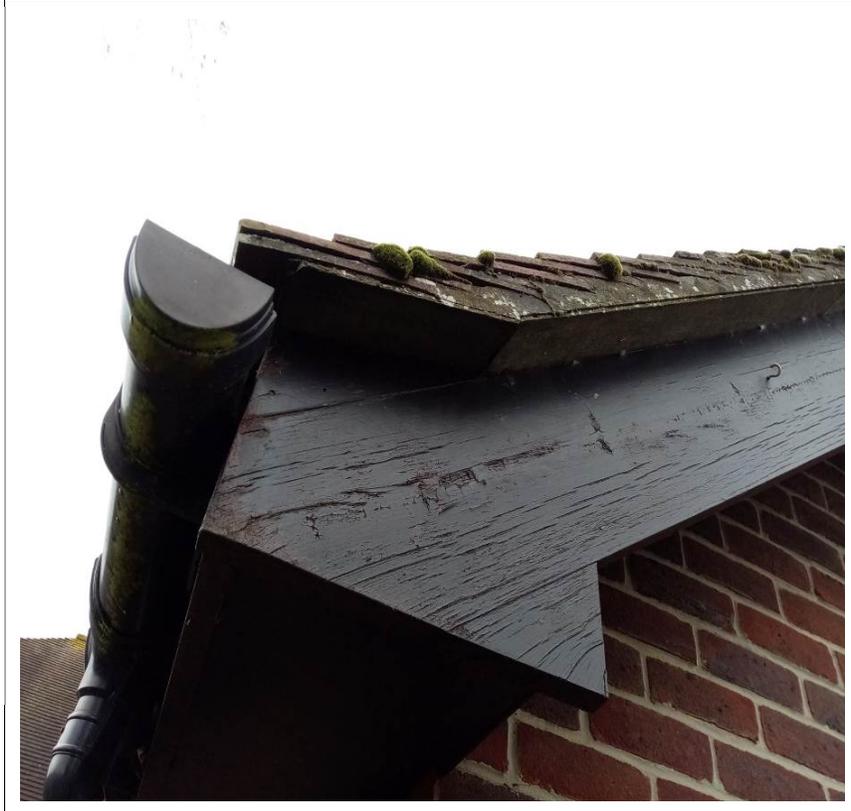
PHOTOPLATE 025

Building: Main					
Location	Item	Photo N°	Product Details	Finding	Recommended/ Action
EX.02 – External Elevations	10	25	Cement under cloaking	Was found to contain Chrysotile (White Asbestos)	Mark and manage

Room Number/ Name Product Details	Item No.	Bulk ID/ Vis ID	Photo No.	Product Type 1-3	Surface Treatment 0-3	Condition 0-3	Asbestos Type NAD, 1-3	Score	Possible Disturbance	Quantity M, M2,x?	ID A, SP, P	Rmd MM, E, R, Other
EX.02 – External Elevations Cement under cloaking	10	AA21310 B10	25	1	1	0	1	3	1	31m	A	MM

Location EX.02 – External Elevations
Item No. 10
Sample Reference (Bulk ID) AA21310 B10
Product Details Cement under cloaking
Analysis Result Chrysotile
Risk Level Very low
Recommendation Mark and manage
